IMPROVING THE OPERATION OF THE SCELB1-8H STEP SWITCH

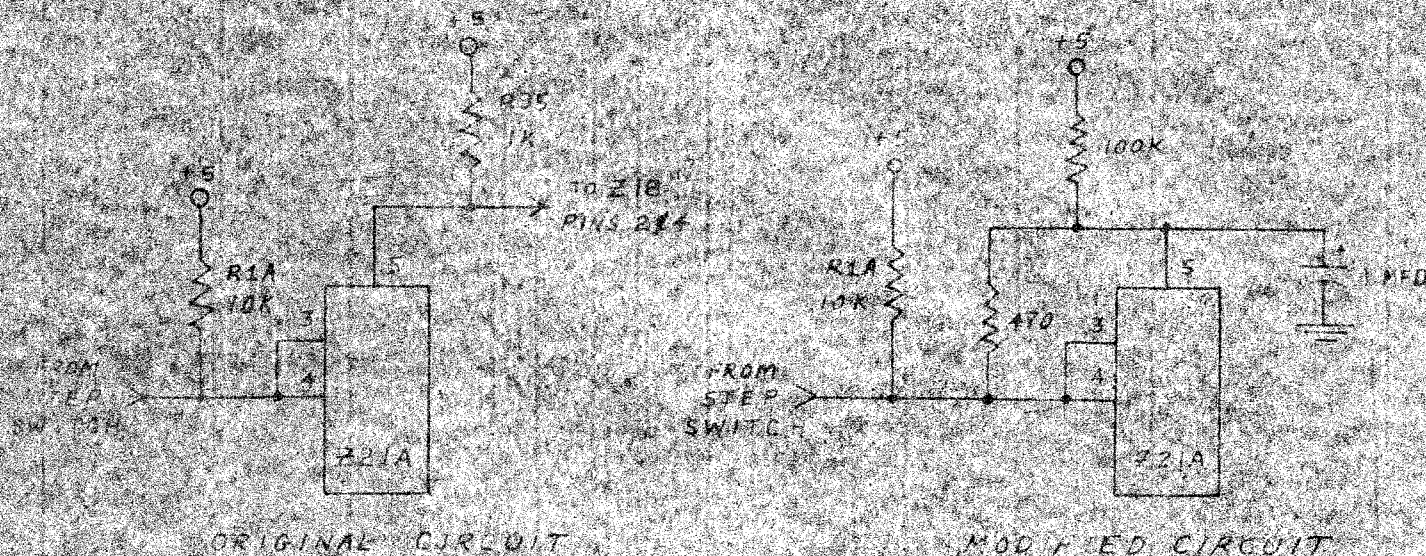
SEVERAL OF OUR CUSTOMERS HAVE EXPERIENCED DIFFICULTY WHEN USING THE STEP SWITCH ON THE SCELB1-8H. THE SYMPTOMS HAVE BEEN EXPRESSED AS "ERRATIC" OPERATION IN THAT SOMETIMES THE COMPUTER WOULD ADVANCE TWO CYCLES AND AT OTHER TIMES WOULD FAIL TO STEP WHEN THE SWITCH WAS OPERATED.

THE FIRST MODIFICATION ELIMINATES THE POSSIBILITY OF CONTACT BOUNCE UPON RELEASE OF THE STEP SWITCH CAUSING MULTIPLE STEP OPERATION.

- 1.) CIRCUIT MODIFICATION TO THE CPU CARD STEP CIRCUITRY AT I.C. 221A. CHANGE THE CIRCUITRY AT 221A TO APPEAR AS SHOWN IN THE SCHEMATIC BELOW.

THE CHANGE CONSIST OF ADDING TWO RESISTORS (CA 470 OHM AND A 100,000 OHM $1/4$ WATT) PLUS A 1 MFD CAPACITOR AT 221A AS ILLUSTRATED IN THE SCHEMATIC. THE ADDITION OF THE COMPONENTS CAN BEST BE IMPLEMENTED BY MOUNTING THE PARTS ON THE CIRCUIT SIDE OF THE CPU CARD AS SHOWN IN THE DIAGRAM ON THE NEXT PAGE. THE DIAGRAM SHOWS THE FOIL PATTERN ON THE CIRCUIT SIDE OF THE CARD IN THE VICINITY OF I.C. 221A (TOWARDS THE UPPER RIGHT HAND CORNER NEAR THE TRIMPOTS WHEN VIEWED FROM THE BACK OF THE CARD WITH THE CONNECTOR PINS EDGE OF THE CARD NEAREST THE OBSERVER). BE SURE TO CUT THE P.C. FOIL AT THE POINT NEXT TO THE FOIL PAD MARKED "A" IN THE DIAGRAM.
